CADILLAC NORTHSTAR 4.6/4.0 M11X1.5 HEAD BOLT THREAD REPAIR KIT

NS300L™ INSERT SYSTEM

93-2011 4.6L CADILLAC NORTHSTAR 95-99 4.0L OLDSMOBILE AURORA

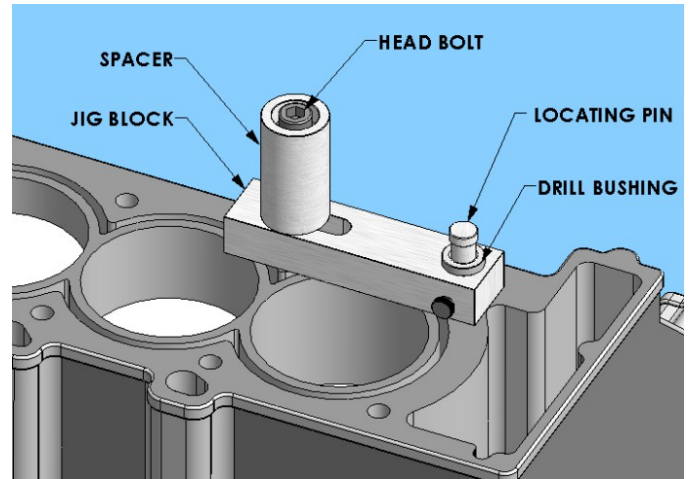
FIGURE 1A

2. **Figure 1A** – Install the Drill Bushing into the Jig Block, then snug it in place with the thumb screw located on the side of the Jig. Make sure the deck surface is clean. Mount the Jig Block in a good head bolt hole near the hole being repaired, using the tall Spacer (see note below), along with a **NEW** head bolt (**old head bolt threads are normally stretched out of pitch, causing them to seize in the new insert**). With the jig loose, center the Drill Bushing over the hole being repaired by install the Locating Pin through the Drill Bushing and into the top of the hole. Hold Locating Pin down firmly so that the tapered end of the pin centers itself into the top of the hole. Tighten the Jig in place, being careful not to over tighten. Remove the Locating Pin.

Note: The tall spacer is designed to be used either with the recessed end facing up, or facing down depending on the engine being repaired. For 93-99 Northstars, the recessed end should be facing up for all holes. Since the 2000-2001 Northstars have two different depth holes, the recessed end should be facing up for the lower bank holes, and facing down for the upper bank holes.

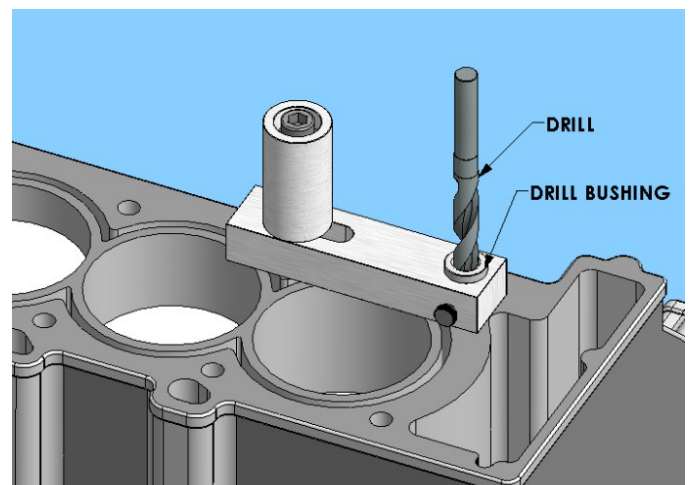
FIGURE 2A

3. **Figure 2A**- Drill the holes using the 17/32" Drill Bit that comes in the kit. Use light penetrating oil to keep the drill lubricated. Retract the drill several times to help clear the chips from the Drill Bits flutes. After you have drilled about 2" deep, you can remove the Drill Bushing from the Jig, then drill the remainder of the hole without it. This will allow for more chip clearance. Drill to the same depth as the original holes. Do not force the drill after it reaches the bottom of the original hole.

Note: The Drill Bits cutting edges are ground to a neutral angle to help prevent it from grabbing when drilling. The tip of the Drill Bit is ground off to prevent it from drilling deeper than the original hole.

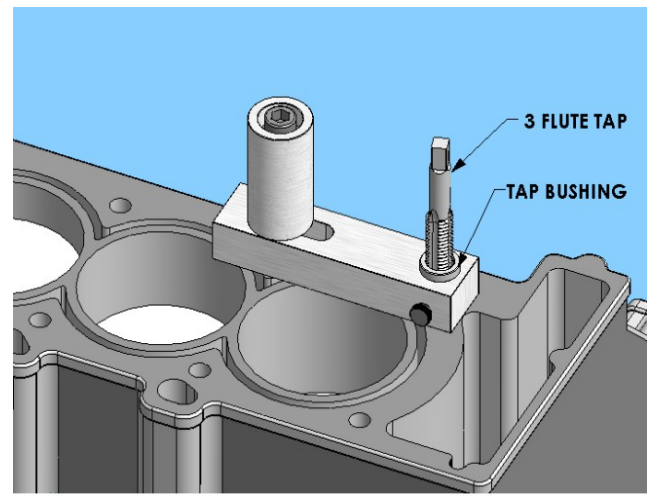
FIGURE 3A

5. **Figure 3A-** Loosen the thumb screw and replace the Drill Bushing with the Tap Bushing. Using the 5/8-11 three-flute Plug Tap, TAP MAGIC® and the proper tap wrench, thread the hole about 1½” deep. **NEVER use power tools or ratchet and socket to drive the taps! This will put unbalanced pressure on the tap causing it to break. Proper tap wrenches apply balanced pressure to the tap.** Then you can remove the jig. This will make it easier to clean out the chips when threading the remainder of the hole. You should back out the tap often and remove the chips created by the tap so that the tap will not jam them into the bottom of the hole. Failure to do so could cause the tap to break.

6. The 5/8-11 four-flute Bottom Tap is only used to form the last couple of threads that the three-flute plug tap did not completely form due to its tapered end. ***The Four flute tap is not designed for heavy cutting!*** This allows the insert to be installed about ¼” deeper. Be careful not to over-tighten and break the tap at the bottom of the hole.
7. Thoroughly clean the newly threaded hole of any metal chips. Next, check to make sure the inserts will install to the correct depths (see below), ***prior*** to adding Threadlock (Figure 4).

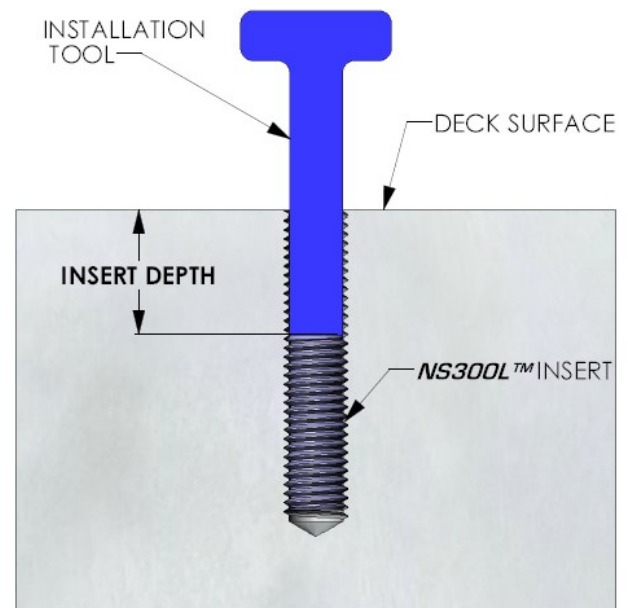
FIGURE 4

8. After insert depth is confirmed, remove the insert. Clean the threaded hole and outside thread of the insert with Brake Cleaner to remove all oil residue. After the Brake Cleaner evaporates, add a couple drops of Threadlock to the newly threaded hole, approximately 1” from the deck surface. Add a bead of Threadlock around the outside of the insert about half way down the length of the insert. **DO NOT GET THREADLOCK ON THE INTERNAL THREADS OF THE INSERT.** Install the insert with the installation tool, until the insert is installed to the correct depth. ***Caution! Threadlock sets up fast! Once you start installing the insert, continue until it is installed to its final depth!*** Allow Threadlock to set for 1-2 hours before installing the head bolts. Make sure there are no sharp edges protruding up from the newly threaded holes before installing the head gaskets and alignment bushings.
